**Flood Control Project Maintenance  
Levee Inspections****LMA District Cover Sheet****Spring 2016 Levee Inspection Results****Reclamation District No. 2075 McMullin**

**Spring 2016 Levee Inspection Results**

**Reclamation District No. 2075 McMullin**

Waterway			Bank	Unit Miles
Unit No. 01 San Joaquin River			Right	7.45
	Spring (March - May)	Summer (June - August)	(September - November) Fall	Winter (December - February)
Unit Maintenance Rating (Fall Only)				
Date of Inspection	3/23/2016 - 3/23/2016			
DWR Inspector	Herman Phillips			
Accompanied By	Eddie Cordoza RD 2075

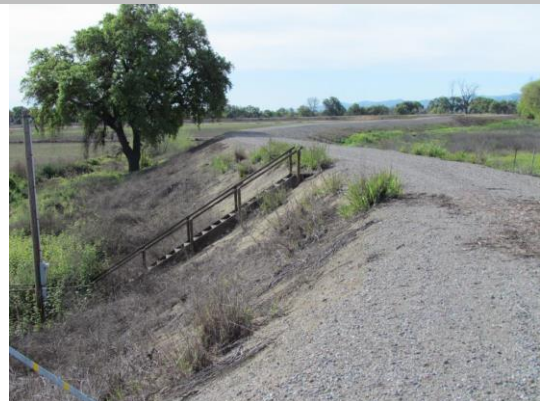
Photo 1 of 1 : SP\_2016\_RD2075\_315\_18\_20160404\_00031.jpg

LM Start	0.10	Rating **	A	Issue No.	18
LM End	5.21	Issue Type +	Ma	Location *	LS
Category	Earthen Levee			GPS Latitude/Longitude	
				Start	End
Item	Vegetation			37.748492 °	37.728805 °
				-121.289720 °	-121.275083 °
DWR ID	DWR_RD2075_01_s_2016_18				
Comment Code					
V1 : Control annual grass and weeds on the levee slopes and easements.					
Inspector Comment					
The RD has sprayed the levee section both landside and waterside slopes.

Looking downstream from levee mile 0.10 landside slope RD 2075.

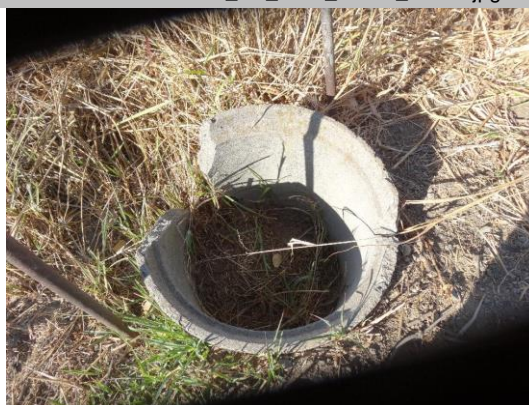
Photo 2 of 2 : UCIP\_SP\_2016\_24663\_44021.jpg

LM Start	0.12	Rating **	M	Issue No.	26
LM End	0.12	Issue Type +	En	Location *	LS
Category	Supplemental			GPS Latitude/Longitude	
				Start	End
Item	DWR UCIP Field Study			37.748200 °	37.748200 °
				-121.289717 °	-121.289717 °
DWR ID					
Comment Code					
Inspector Comment					
FS_ID:24663 DS_ID:24735 EP_NO: 4736 Repair Type: Non-Urgent Crossing Status: Found UCIP Comments: - pipe not visible on waterside.- no access to concrete riser on waterside.- blocked siphon breaker. FIELD_STRUCT_DESC: 14-inch steel pipe through the levee, 4.0 feet below the crown. Pump mounted on pile structure in drainage ditch on the landside. Siphon breaker in concrete riser unit on the waterward slope. Concrete distribution box at the toe of waterward slope. (App. No. 4736 - E. E. Brown). O&M Manual SJR 003, Dec. 1968. FS Date: 11/13/2013

WS view: concrete pipe riser with siphon breaker on levee slope.

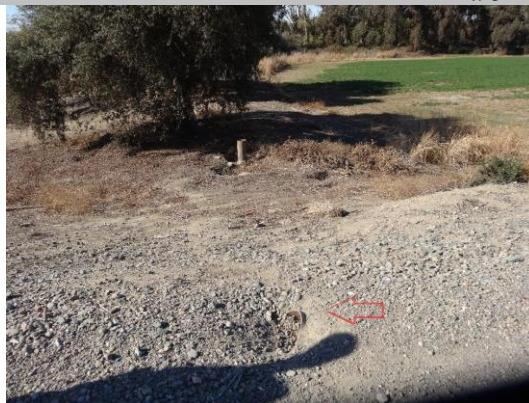
Photo 1 of 2 : UCIP\_SP\_2016\_24666\_45600.jpg

LM Start	2.32	Rating **	M	Issue No.	27
LM End	2.32	Issue Type +	En	Location *	LS
Category	Supplemental			GPS Latitude/Longitude	
				Start	End
Item	DWR UCIP Field Study			37.731314 °	37.731314 °
				-121.293713 °	-121.293713 °
DWR ID					
Comment Code					
Inspector Comment					
FS_ID:24666					
DS_ID:24737					
EP_NO: N/A					
Repair Type: Non-Urgent					
Crossing Status: Found					
UCIP Comments: - service pole on landside.- looks abandoned.					
Walkway in dilapidated condition.					
FIELD_STRUCT_DESC: 16-inch pipe through the levee, 4.5 feet below the crown. Pump mounted on pile structure in drain ditch on the landward side. Siphon breaker in CM riser unit on the waterward slope.					
O&M Manual SJR 003, Dec. 1968.					
FS Date: 11/13/2013

WS view: concrete standpipe (top) and steel pipe riser (bottom marked) on levee slope.

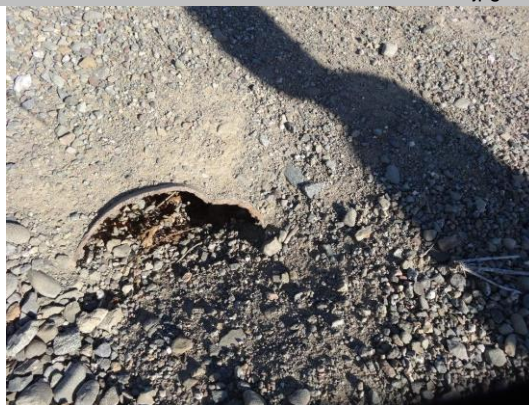
Photo 2 of 2 : UCIP\_SP\_2016\_24666\_44030.jpg

WS view: blocked siphon breaker in steel pipe riser on levee slope.

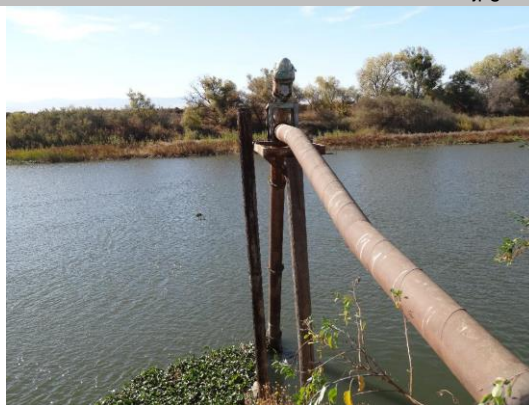
Photo 2 of 2 : UCIP\_SP\_2016\_41721\_45981.jpg

LM Start	3.86	Rating **	M	Issue No.	29
LM End	3.86	Issue Type +	En	Location *	LS
Category	Supplemental			GPS Latitude/Longitude	
				Start	End
Item	DWR UCIP Field Study			37.713744 °	37.713744 °
				-121.280712 °	-121.280712 °
DWR ID					
Comment Code					
Inspector Comment					
FS_ID:41721					
DS_ID:24746					
EP_NO: N/A					
Repair Type: Non-Urgent					
Crossing Status: Found					
UCIP Comments: Several concrete structure with Alfalfa valve. Only steel pipe visible on river bank. Service pole on waterside.New field discovered crossing.					
FIELD_STRUCT_DESC: 10-inch irrigation pvc pipe through the levee. Slant pump in river bank. Distribution box on levee berm on waterside. U type concrete headwall and open outlet on levee toe on landside.					
FS Date: 11/13/2013

WS view: slant pump on timber pile in the stream.

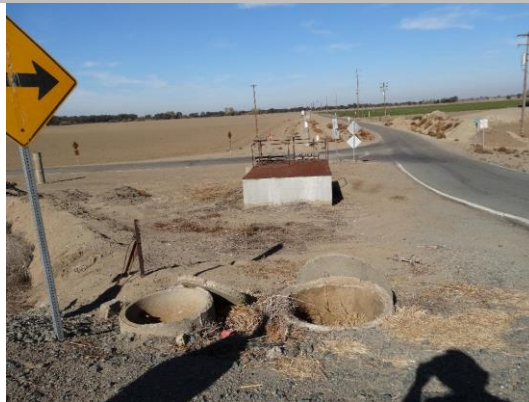
Photo 2 of 2 : UCIP\_SP\_2016\_41747\_45602.jpg

LM Start	5.20	Rating **	M	Issue No.	30
LM End	5.20	Issue Type +	En	Location *	LS
Category	Supplemental			GPS Latitude/Longitude	
				Start	End
Item	DWR UCIP Field Study			37.728853 °	37.728853 °
				-121.275220 °	-121.275220 °
DWR ID					
Comment Code					
Inspector Comment					
FS_ID:41747					
DS_ID:24739					
EP_NO: N/A					
Repair Type: Non-Urgent					
Crossing Status: Found					
UCIP Comments: - flap gates in concrete box on LS toe have failed and are open. Rusted through flapgate may indicate condition of interior of pipe.					
FIELD_STRUCT_DESC: 1 of 2: Two 16- inch pipes through the levee, 8.0 feet below the crown. Pump mounted on pile structure in the river. Walkway to the pumps. Siphon breakers and concrete distribution box on the landward slope. Electric conduit through the levee. O&M Manual SJR 003, Dec. 1968.					
FS Date: 11/13/2013

LS view: siphon breakers in concrete pipe risers (bottom) on levee slope. Concrete distribution box on levee toe (top).

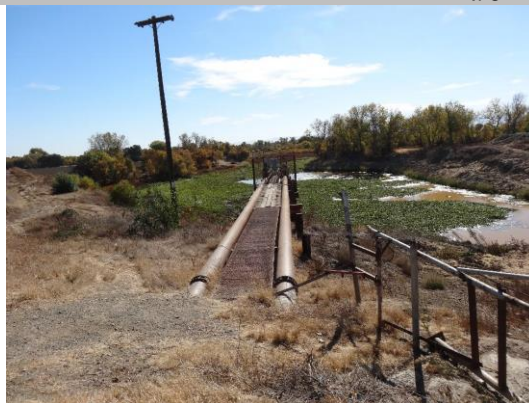
Photo 1 of 2 : UCIP\_SP\_2016\_25184\_45608.jpg

LM Start	5.20	Rating **	M	Issue No.	24
LM End	5.20	Issue Type +	En	Location *	LS
Category	Supplemental			GPS Latitude/Longitude	
				Start	End
Item	DWR UCIP Field Study			37.728848 °	37.728848 °
				-121.275195 °	-121.275195 °
DWR ID					
Comment Code					
Inspector Comment					
FS_ID:25184 DS_ID:24743 EP_NO: N/A Repair Type: Non-Urgent Crossing Status: Found UCIP Comments: Flap gate lid displaced. FIELD_STRUCT_DESC: 2 of 2: Two 16-inch pipes through the levee, 8.0 feet below the crown. Pump mounted on pile structure in the river. Walkway to the pumps. Siphon breakers and concrete distribution box on the landward slope. Electric conduit through the levee. O&M Manual SJR 003, Dec. 1968. FS Date: 11/13/2013

WS view: two pipes, walkway to pump and pile structure in the stream.

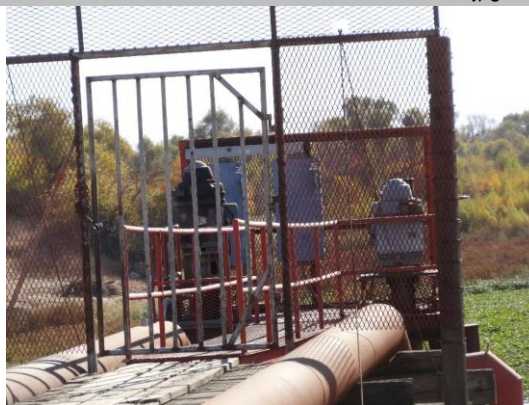
Photo 2 of 2 : UCIP\_SP\_2016\_25184\_45607.jpg

WS view: closer view of two pumps and platform in the stream.

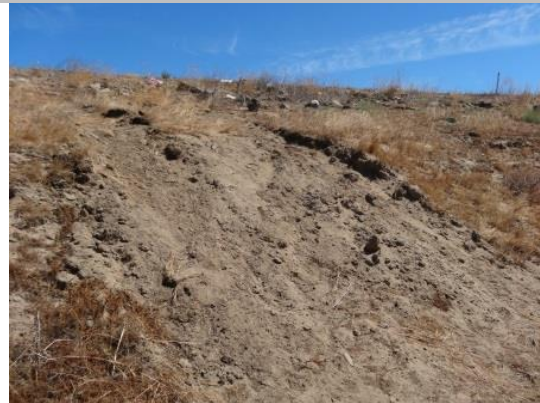
Photo 1 of 3 : SP\_2016\_RD2075\_315\_1\_20160223\_00001.jpg

Comment Code					
Inspector Comment					
08/28/2015: No significant change observed. Loose material is visible at the upper levee slope. The loose soil may have been caused by runoff.					
08/18/2014: No significant change observed.					
09/10/2013: No significant change observed.					
09/13/2012: No significant change observed.					
08/18/2011: No significant change observed. Some new material added to the water side levee slope, but the added material is loose and seems not helping the levee protection.					
10/05/2010: No significant change observed. Levee slope has minimal vegetation and lacks rip rap protection. Sandy material found on the lower and middle slope is an undesirable material to have on a levee.					
08/05/2010: Recommended for annual assessment and monitoring during flood events, per CLRO.					
08/20/2009: No major change since last visit; site is located in an oxbow; slope surface consists of very sandy material; there is a tree on site leaning and with exposed tree roots; site is recommended as a local maintenance issue, per CLRO CES Evaluation 2008 Report; Eddy Cordoza from the district is aware of the site and is looking for recommendation; site is previously rated "U".

Direct view of the levee slope. Note the loose soil possibly caused by runoff.

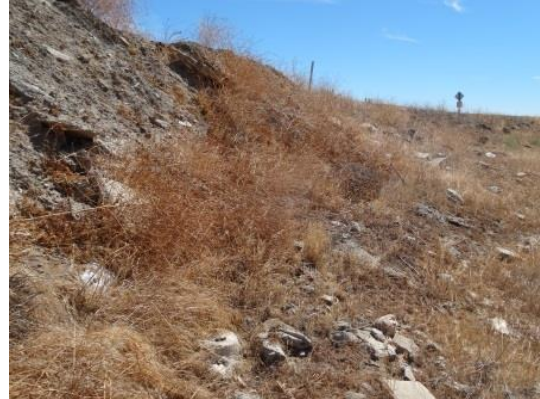
Photo 2 of 3 : SP\_2016\_RD2075\_315\_1\_20160223\_00002.jpg

Comment Code					
Inspector Comment					
08/28/2015: No significant change observed. Loose material is visible at the upper levee slope. The loose soil may have been caused by runoff.					
08/18/2014: No significant change observed.					
09/10/2013: No significant change observed.					
09/13/2012: No significant change observed.					
08/18/2011: No significant change observed. Some new material added to the water side levee slope, but the added material is loose and seems not helping the levee protection.					
10/05/2010: No significant change observed. Levee slope has minimal vegetation and lacks rip rap protection. Sandy material found on the lower and middle slope is an undesirable material to have on a levee.					
08/05/2010: Recommended for annual assessment and monitoring during flood events, per CLRO.					
08/20/2009: No major change since last visit; site is located in an oxbow; slope surface consists of very sandy material; there is a tree on site leaning and with exposed tree roots; site is recommended as a local maintenance issue, per CLRO CES Evaluation 2008 Report; Eddy Cordoza from the district is aware of the site and is looking for recommendation; site is previously rated "U".

Looking downstream at the erosion site.

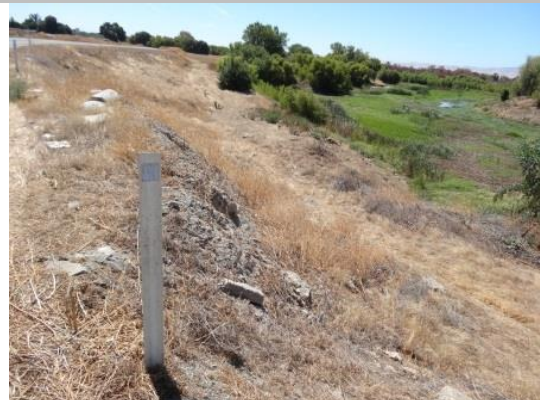
Photo 3 of 3 : SP\_2016\_RD2075\_315\_1\_20160223\_00003.jpg

Looking upstream at the site.

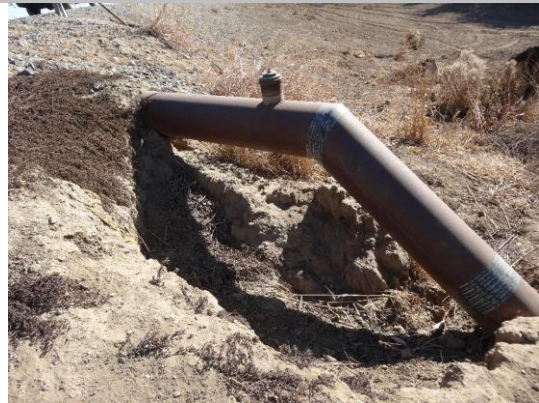
Photo 1 of 2 : UCIP\_SP\_2016\_24723\_44262.jpg

Comment Code					
Inspector Comment					
FS_ID:24723 DS_ID:24740 EP_NO: 3492 Repair Type: Urgent Crossing Status: Found UCIP Comments: Huge erosion on waterside levee slope due to siphon breaker leakage.It is not 16-inch but 12-inch steel pipe.Pump not mounted on pile structure but mounted on concrete sump.Siphon breaker not in concrete riser but on steel pipe.Pipe is not 8 ft. below the crown but 4 ft below the crown.Looks original pipe was replaced with new crossing. Needs more information from LMA or DWR Inspector. FIELD_STRUCT_DESC: 12-inch pipe through the levee, 4.0 feet below the crown. Pump mounted on concrete sump in drain ditch on the landside. Siphon breaker on the waterside slope. (App. No. 3492&A - RD2075) O&M Manual SJR 003, Dec. 1968. FS Date: 11/13/2013

WS view: siphon breaker on steel pipe on levee slope. Huge soil erosion due to siphon breaker leakage.

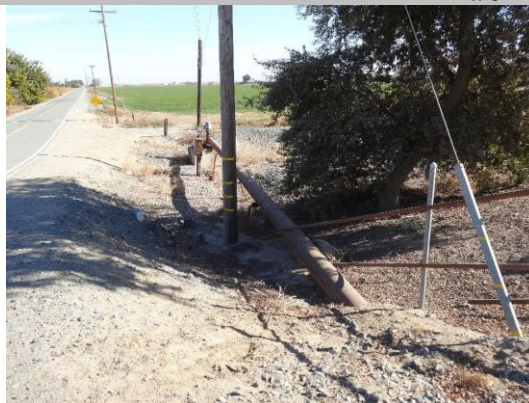
Photo 2 of 2 : UCIP\_SP\_2016\_24723\_44261.jpg

Comment Code						
Inspector Comment						
FS_ID:24723						
DS_ID:24740						
EP_NO: 3492						
Repair Type: Urgent						
Crossing Status: Found						
UCIP Comments: Huge erosion on waterside levee slope due to siphon breaker leakage.It is not 16-inch but 12-inch steel pipe.Pump not mounted on pile structure but mounted on concrete sump.Siphon breaker not in concrete riser but on steel pipe.Pipe is not 8 ft. below the crown but 4 ft below the crown.Looks original pipe was replaced with new crossing. Needs more information from LMA or DWR Inspector.						
FIELD_STRUCT_DESC: 12-inch pipe through the levee, 4.0 feet below the crown. Pump mounted on concrete sump in drain ditch on the landside. Siphon breaker on the waterside slope. (App. No. 3492&A - RD2075) O&M Manual SJR 003, Dec. 1968.						
FS Date: 11/13/2013

LS view: pipe, pump and concrete sump in the drain ditch.

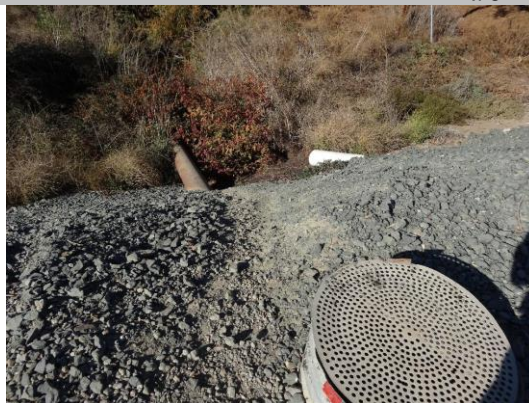
Photo 1 of 2 : UCIP\_SP\_2016\_43027\_45613.jpg

FS\_ID:43027  
DS\_ID:24742  
EP\_NO: 4051  
Repair Type: Urgent  
Crossing Status: Found  
UCIP Comments: - exposed deformed pipe on landside slope. Soil erosion also occurred around the deformed pipe. Walkway at pump on LS toe in poor structural condition.- a temporary 12-inch PVC pipe also found on both sides of the levee.  
FIELD\_STRUCT\_DESC: 12-inch pipe through the levee, 5.5 feet below the crown. Pump mounted over concrete sump at the landside levee toe. Siphon breaker in CM riser unit on the waterward shoulder. 12-inch PVC pipe 1.0 foot below the crown Installed for emergency use during 1986 floods. (App. No. 4051). O&M Manual SJR 003, Dec. 1968.  
FS Date: 11/13/2013

WS view: CMP riser (bottom) on levee shoulder. Steel pipe (top) and temporary pvc pipe on levee slope.

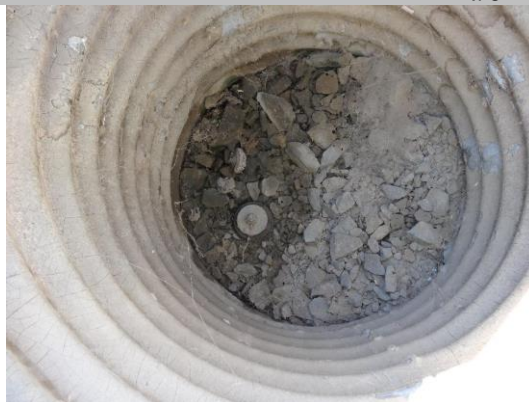
Photo 2 of 2 : UCIP\_SP\_2016\_43027\_45612.jpg

WS view: siphon breaker in CMP riser on levee shoulder.

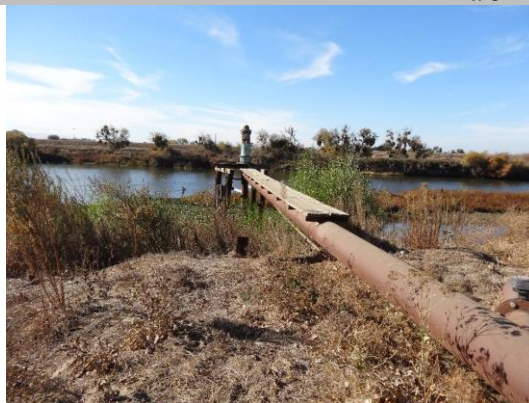
Photo 1 of 2 : UCIP\_SP\_2016\_24738\_44342.jpg

LM Start	7.43	Rating **	M	Issue No.	25
LM End	7.43	Issue Type +	En	Location *	WS
Category	Supplemental			GPS Latitude/Longitude	
				Start	End
Item	DWR UCIP Field Study			37.710421 °	37.710421 °
				-121.268221 °	-121.268221 °
DWR ID					
Comment Code					
Inspector Comment					
FS_ID:24738 DS_ID:24734 EP_NO: 2150 Repair Type: Non-Urgent Crossing Status: Found UCIP Comments: Most of the pipe exposed on waterside.Needs investigation regarding levee subsidence along pipe alienment on landside slope. FIELD_STRUCT_DESC: 12-inch pipe through the levee, 4.5 feet below the crown. Pump mounted on pile structure in the river. Concrete distribution box at the landward toe. Electric conduit through the levee. (App. No. 2150 - Cardoza) O&M Manual SJR 003, Dec. 1968. FS Date: 11/13/2013

WS view: pipe, walkway, and pump on pile structure in the river.

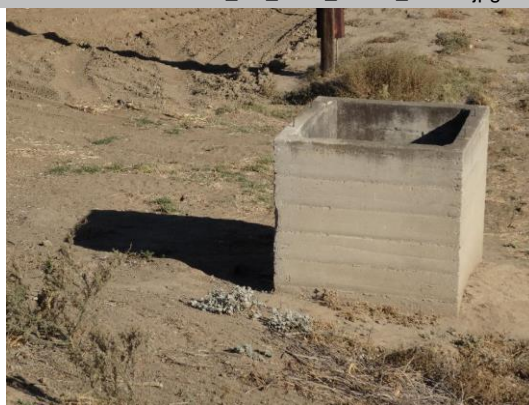
Photo 2 of 2 : UCIP\_SP\_2016\_24738\_44341.jpg

LS view: concrete distribution box on levee toe.
